# PRO'S AND CON'S OF HALF-CELL POTENTIALS AND CORROSION RATE MEASUREMENTS

Structural Faults + Repairs, International Conference, London, U.K., July 1st-July 3rd, 2003

KEYWORDS: Half cell potential (HCP), Corrosion rate ( $I_{\text{corr}}$ ), Galvanostatic Pulse Measurements (GPM), concrete structures

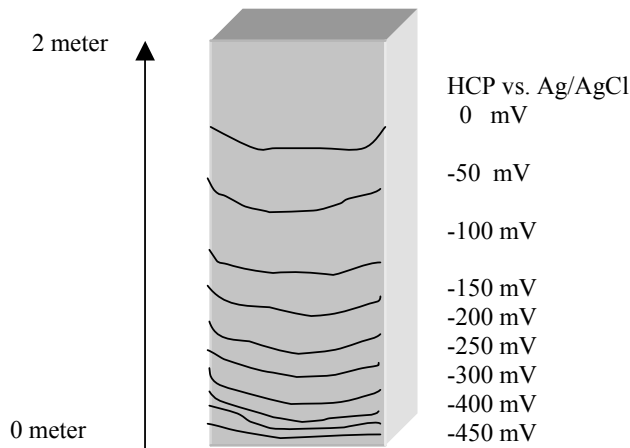
Fig.1. Typical potential map of a high way concrete pillar exposed to de-icing salts

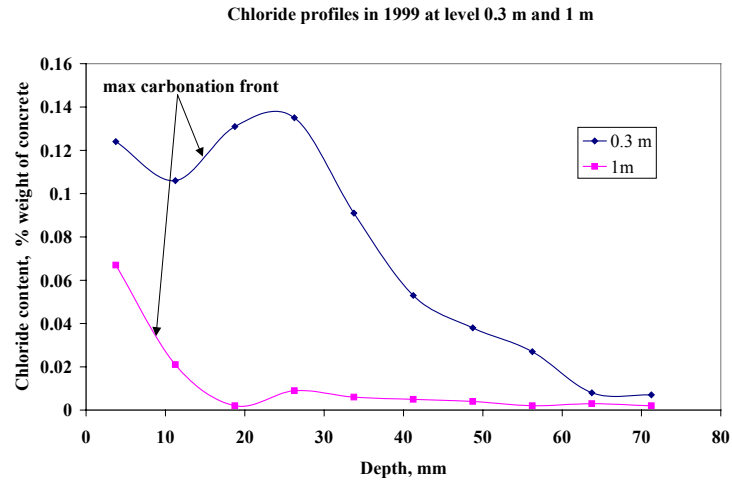
Fig 2. Chloride profiles at level 0.3m and level 1 m

The vertical reinforcement ( $\varnothing 35$  mm) is typically in 60 mm depth and the horizontal ( $\varnothing 14$  mm) in 40 mm depth. Already in 1999 the chloride content in level 0.3 m is so high that active corrosion can be expected. In September 2000 and in April 2001 corrosion rates were determined together with the half-cell potentials and resistance measurements [5] (fig 3).

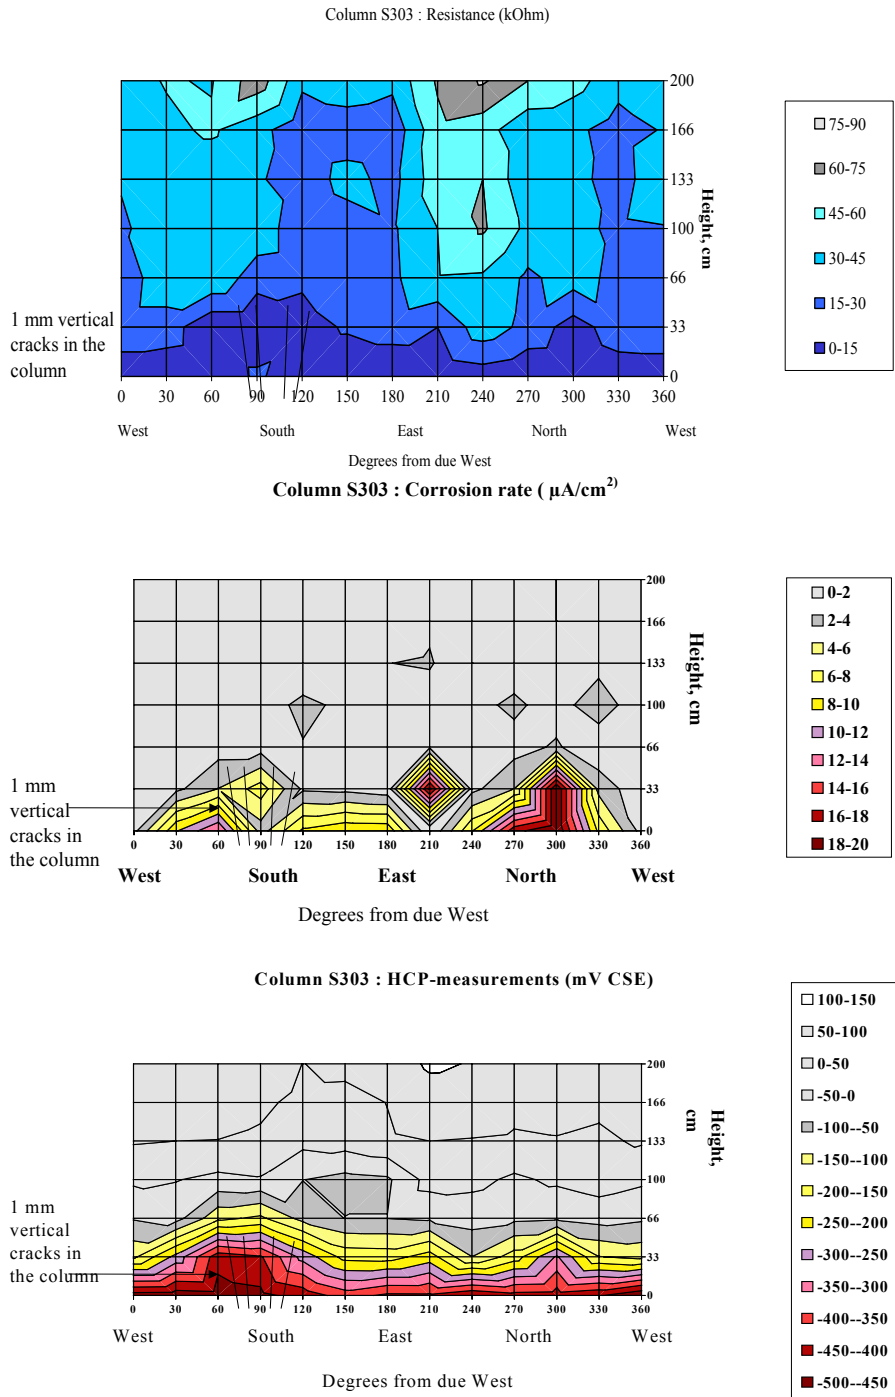
Fig. 3 Resistance, half-cell potentials and corrosion rates in September 2000

In this case there is a rather good correlation between resistance, half-cell potential and corrosion rate mapping. To verify the corrosion state a break-up was made at the position 90 degrees south near ground level, see fig. 4.

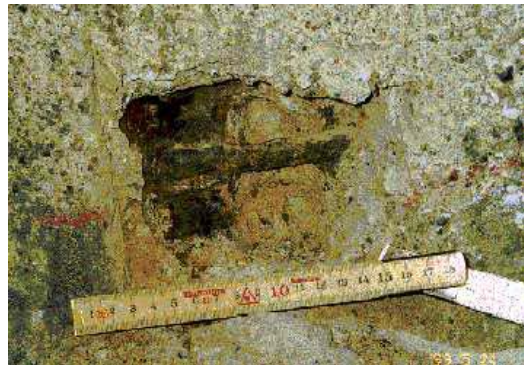
Fig. 4 Corroding reinforcement. Cross section loss : 1-2 mm

As the constructions have been examined close during the last 20 years it is possible to make a good estimate of the initiation of corrosion. Calculation of the average corrosion rate from the cross section loss of app. 2 mm and assuming the corrosion was initiated after app. 10 years gives an average corrosion rate of  $9\mu\text{A}/\text{cm}^2$ , which is with in the range of corrosion rates determined at this position by the GPM. The very low half-cell potentials agree with the high corrosion activity.

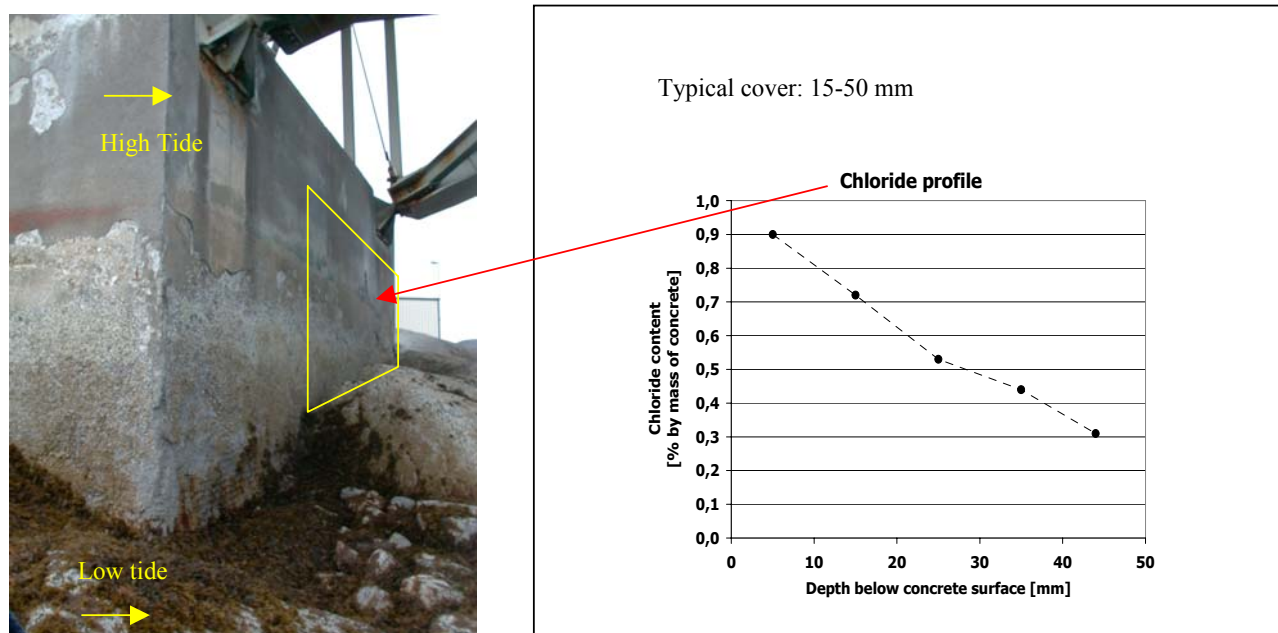
Fig. 5. The investigated area and the location of the chloride profile.

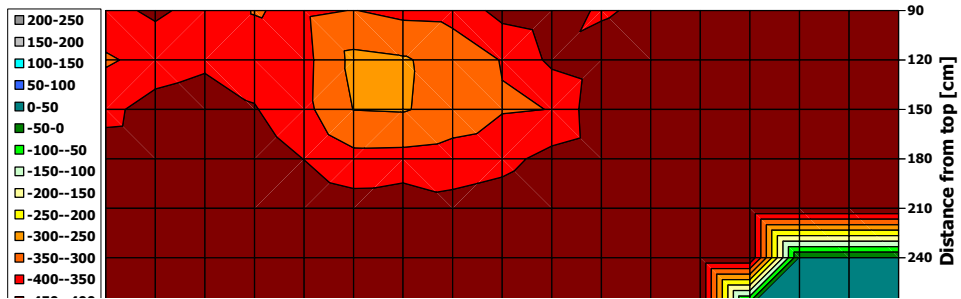
The chloride concentration in the depth of the reinforcement is in the range between 0,3% and 0,7% of the concrete weight. As indicated by the half-cell potential measurements corrosion should therefore be expected. However the measured corrosion rates are low and the verification by visual inspection (fig. 7) shows no damage to the reinforcement.

Half cell potential map of bridge foundation. Potential in mV vs. Ag/AgCl

Fig. 6 HCP and  $I_{\text{corr}}$  of bridge foundation

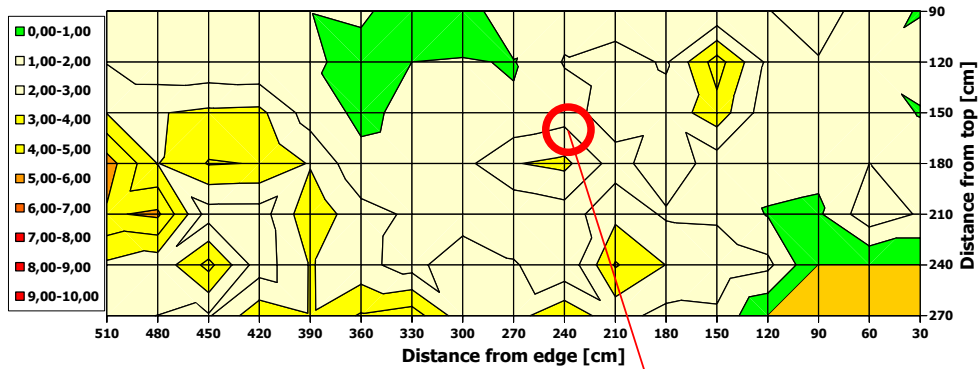
Corrosion rate map. Corrosion rates in  $\mu\text{A}/\text{cm}^2$

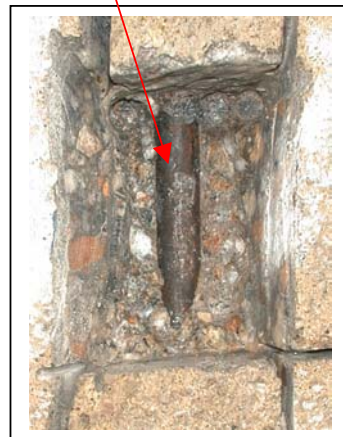
Fig. 7 Foto of break-up

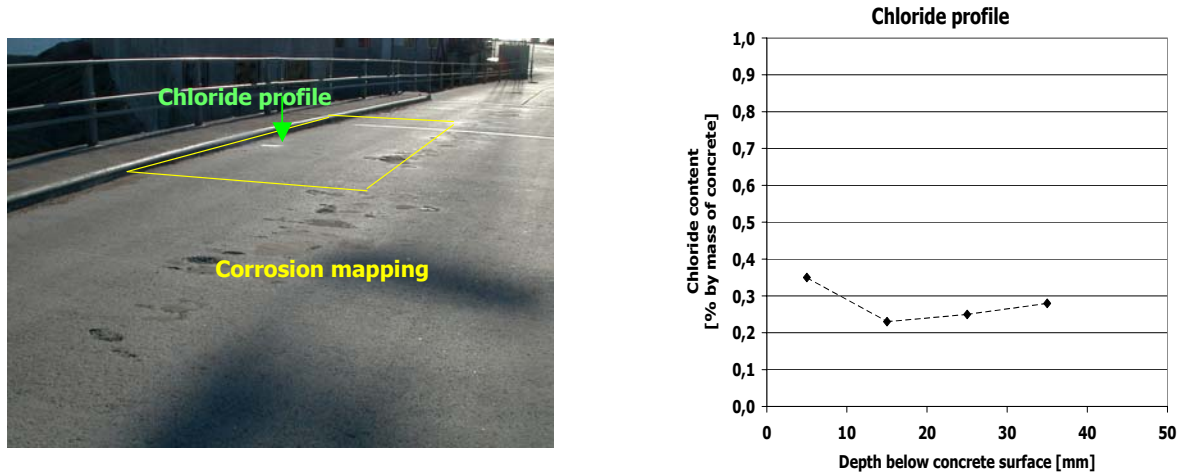
Fig.8 The investigated area and the location of the chloride profile.

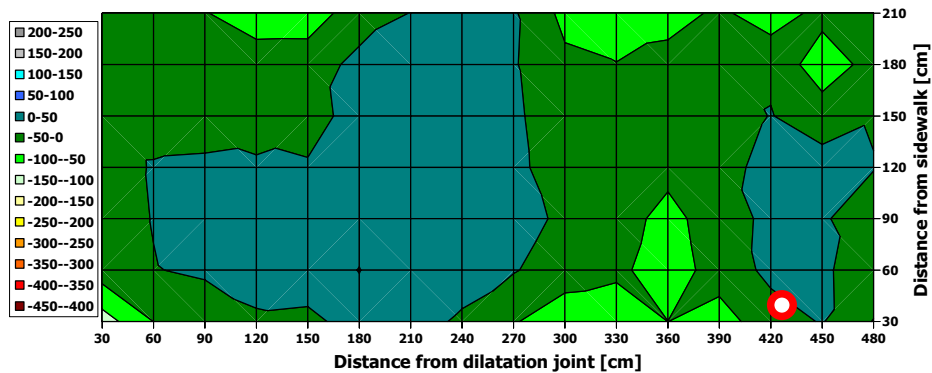
The typical dept of the reinforcement is here minimum 40-50 mm and the chloride concentration in this depth is near 0, 3% of the concrete weight. At this high chloride concentrations the half-cell potentials are expected to be low but the most negative values measured are all above -100 mV vs. Ag/AgCl (fig. 9).

Half cell potentials in mV vs. Ag/AgCl reference electrode

Fig.9. The read circle indicates the location of the chloride profile and the break-up shown at fig. 11.

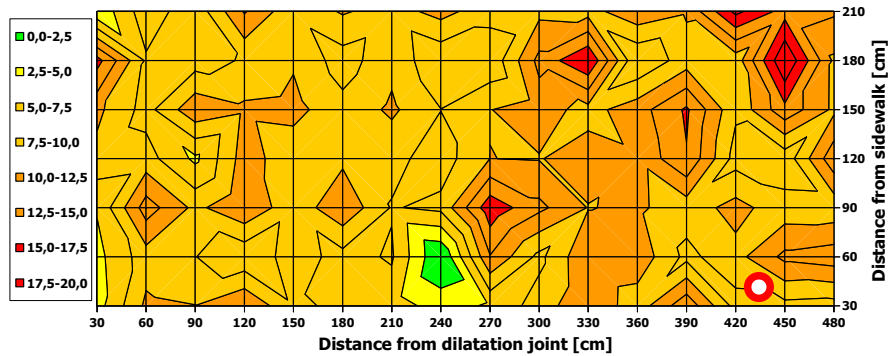
The corrosion rate map fig.10 shows a completely different picture and indicates active corrosion at several locations.

Corrosion rates in  $\mu\text{A}/\text{cm}^2$

Fig.10. Corrosion rate of the bridge deck. The read circle indicates the location of the chloride profile and the break-up shown at fig. 11. The photo in fig 11 shows the reinforcement covered with a thin layer of corrosion products. The ribs at the reinforcement are still intact but corroded.

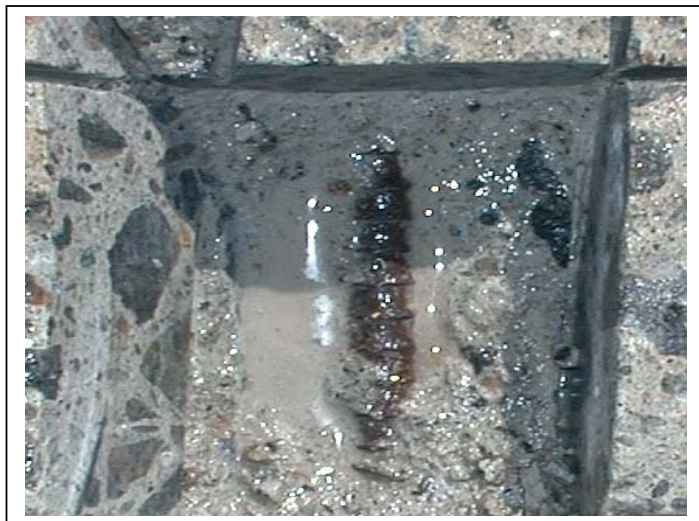
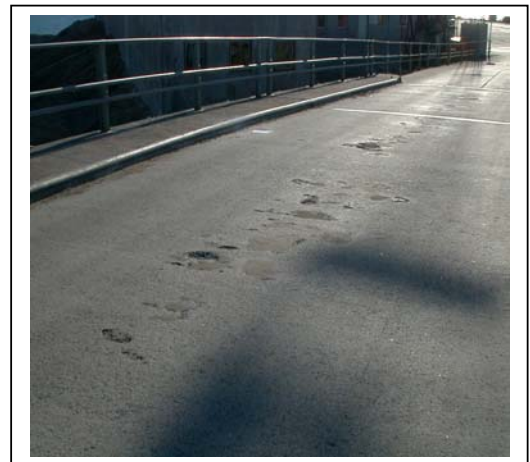
Fig.11. The first picture shows the corroded reinforcement and some water from cooling the diamond cutting blade. The second picture shows the damage and the mortar repairs.

This bridge is located in a very cold environment. During the measurements described above the temperature was  $15\text{ }^{\circ}\text{C}$  at midday and this explains the rather high corrosion rates at the bridge deck. Further there were some damages to the concrete surface due to the traffic directly on the concrete surface and a lot of mortar repairs.

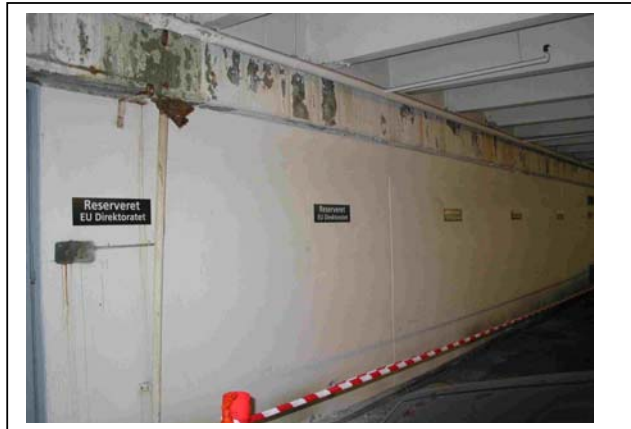
The last example is an underground car park in the Copenhagen area. The rather constant temperature is around 15 °C during the whole year. Most of the observed damages are due to the leakage of water/de-icing salts from the street above. Also de-icing salt from the parked cars in the winter causes damage to the walls near the floor. The concrete was very dry during the investigation. The walls were surface treated with the protective coating. At the locations where water was leaking into the construction the coating was scaling (fig. 12.)

Fig. 12. Leaking of water and de-icing salts cause scaling of coating.

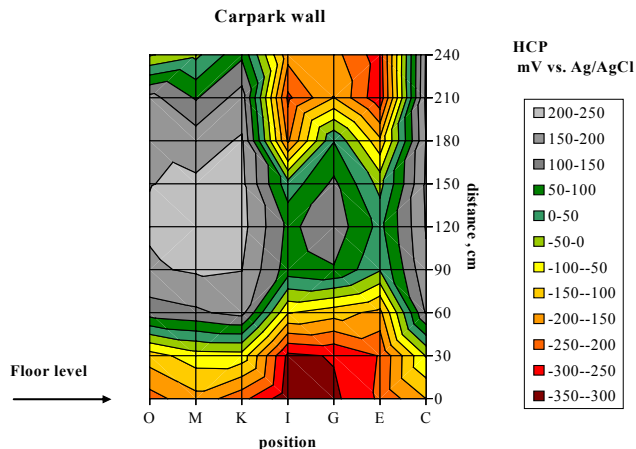
Fig. 13. Potential map of typical area with leakage of water from the street above and capillary suction of water from the car park floor.

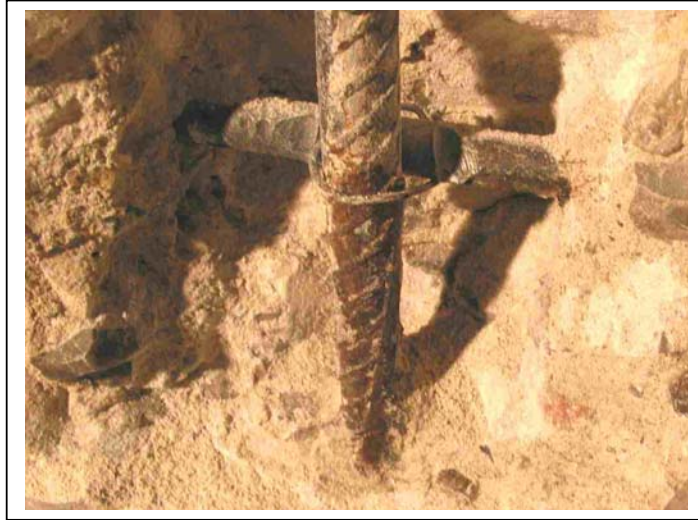
By galvanostatic pulse measurements the actual corrosion rate in the position between I and G at floor level was estimated to be 0,9  $\mu\text{A}/\text{cm}^2$ . The picture (fig. 14) shows some corroded area but no cross section loss and the tie wire is intact. In this example both HCP and GPM measurements point out places

with active corrosion. The rather low corrosion rate is in good correlation with the cross section loss observed while the low half cell potentials indicates a high risk of high corrosion activity.

Fig.14. Exposed reinforcement at floor level in car park wall where HCP show very low values.
