Mini Great Dane

Purpose

The **Mini Great Dane** is used to measure the half-cell potential of uncoated reinforcing steel in concrete (in accordance with ASTM C876) and to measure the electrical resistance of the cover concrete. Typical applications include the following:

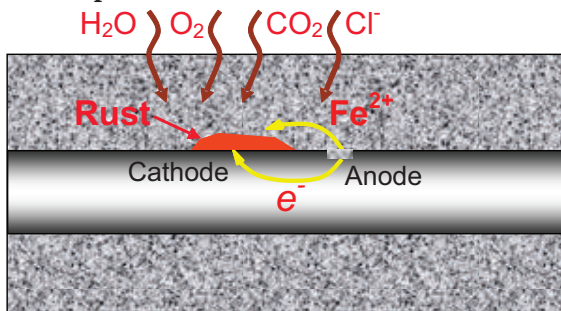
The flow of iron ions through the concrete is associated with a potential field as shown on the right. The **Mini Great Dane** measures the surface potentials (relative to an Ag/AgCl reference electrode) and the electrical resistance of the cover concrete between the electrode and the reinforcement. The indicated potential, E_{corr} , is in terms of a Cu/CuSO₄ electrode (CSE), which are -110 mV lower in value than for the Ag/AgCl electrode. The risk of corrosion is evaluated by means of the steepness of the potential gradients measured at the concrete surface and the level of the electrical resistance of the cover concrete. A large potential gradient and a low concrete resistance will normally indicate a high corrosion rate, except in saturated concrete because of the low oxygen content.

Reinforcement in concrete will not corrode if the protective film formed in the presence of highly alkaline pore fluid with a pH of about 13 is maintained. The passive layer may, however, be destroyed by the ingress of chloride ions or by a reduction in pH due to carbonation. When the passive film is destroyed, corrosion may occur in the presence of moisture and oxygen.

During the corrosion process, anodic and cathodic areas are formed on the reinforcement. At the anodes, iron dissolves and iron ions diffuse into the concrete, leaving behind electrons. At the cathodic sites, the iron ions combine with water and oxygen to form an expansive corrosion product, i.e., rust. The rate of corrosion is controlled by how easily the iron ions can move through the concrete from the anodes to the cathodes and it depends on the availability of oxygen and moisture at the cathodes.

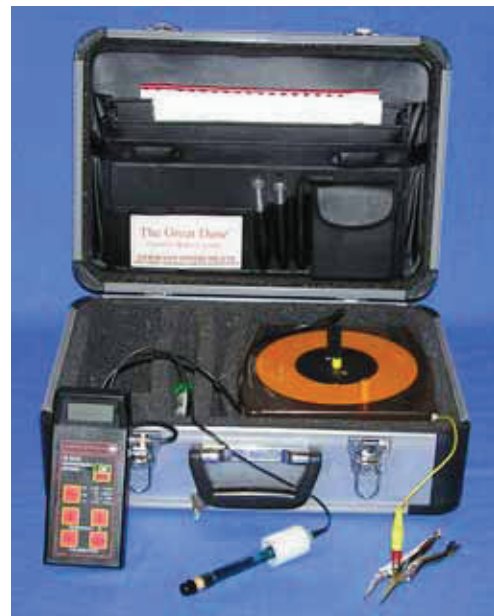
The **Mini Great Dane-2000** Ordering Numbers

| Item | Order # |
| Digital meter with signal box | GD-2001 |
| Ag/AgCl measuring cell | GD-2002 |
| Connecting cable | GD-2003 |
| Cable drum, 15 meters | GD-2004 |
| Reinforcement locator | GD-2005 |
| Drill bits, 10 mm and 18 mm | GD-2006 |
| Two reinforcement adaptors | GD-2007 |
| Allen key | GD-2008 |
| Two reinforcement clamping pliers | GD-2009 |
| Hammer and chisel | GD-2010 |
| Telescoping rod for Ag/AgCl cell | GD-2011 |
